# Railway Inspection with Deep Learning.

Marcel Zurkirchen, SBB AG

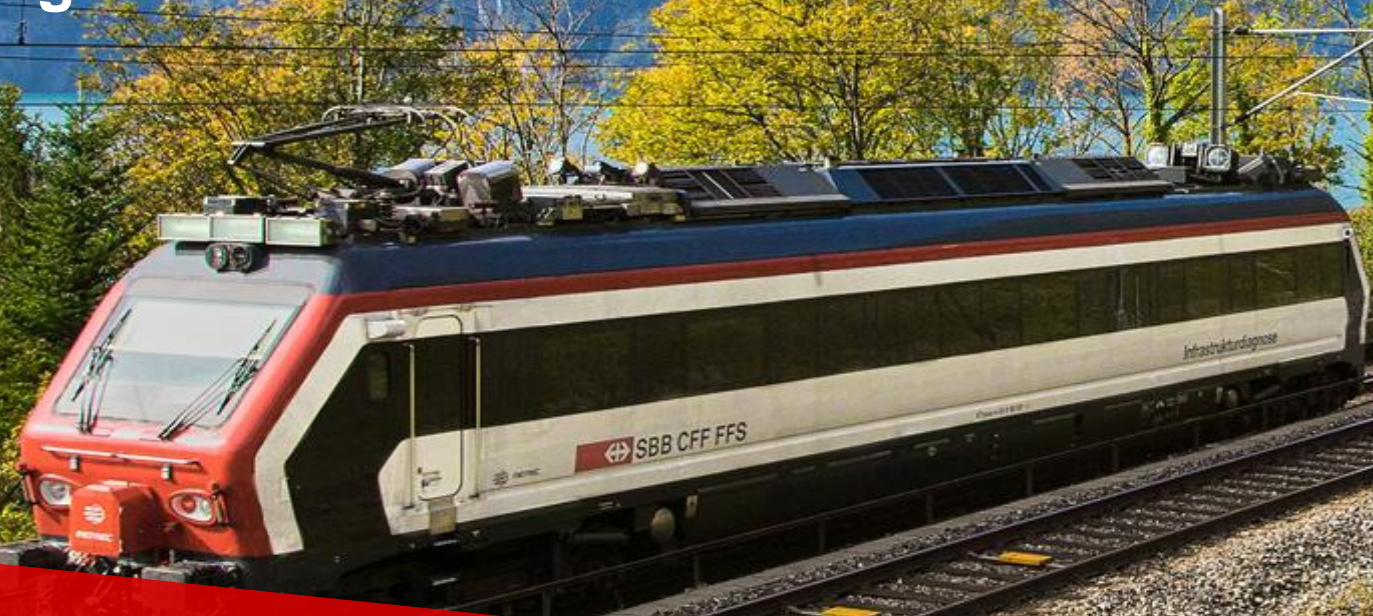
# SBB Diagnostic Vehicle and Coach.

Production Speed up to 200 Km/h  
18 installed High-Speed Camera Systems  
with a Data Output of 10 GB/Km

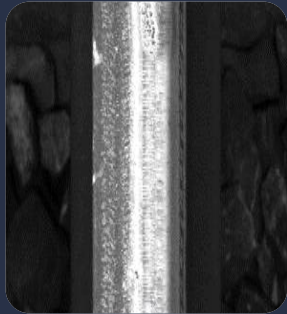
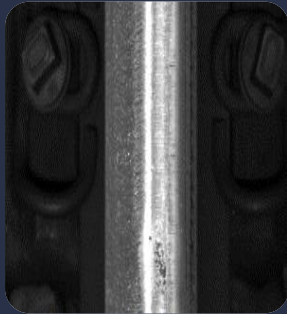
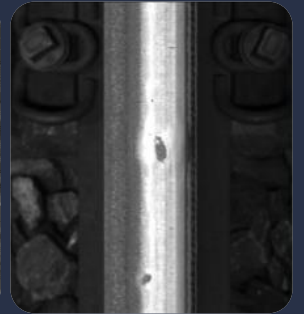
# Evolution of a Defect.

November 2016

February 2017

April 2017

Mai 2017

June 2017

August 2017
